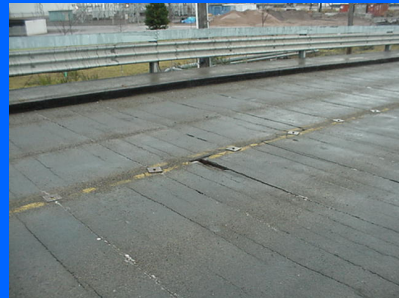
**Approach Deck Condition**

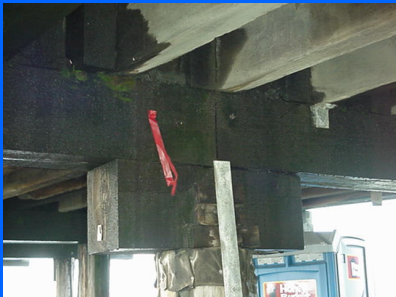
**Approach Span Cap Deterioration**

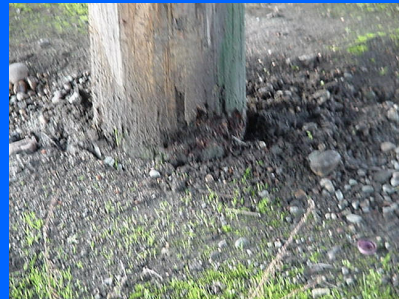
**Approach Pile Rot**

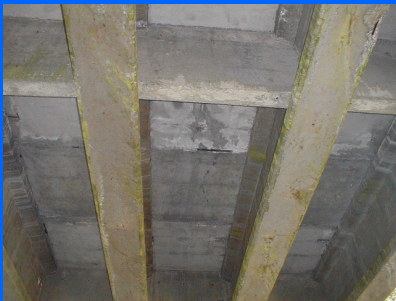
**Bridge Soffit with Exposed Rebar**

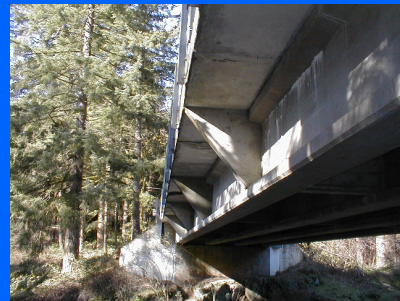
**Deterioration in Overhangs**

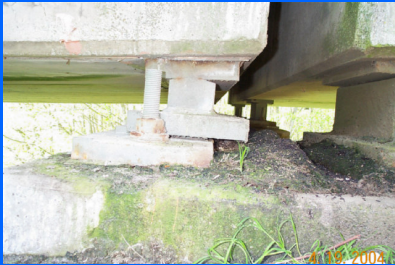
Bearing Condition

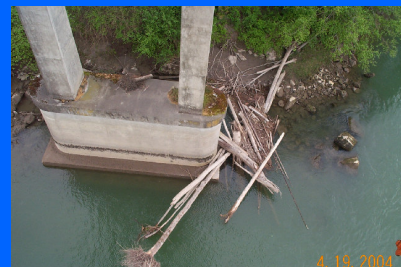
Exposed Footing and Drift Accumulation

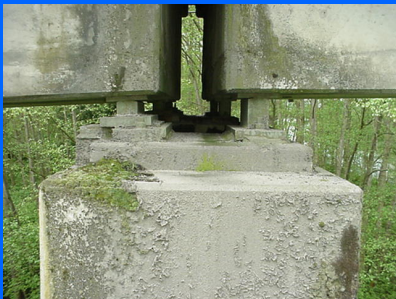
Seismically Vulnerable Bearings

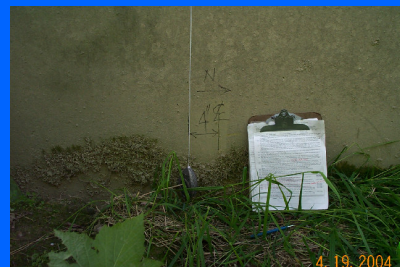
Unstable Pier 8 – 4' Out of Plumb

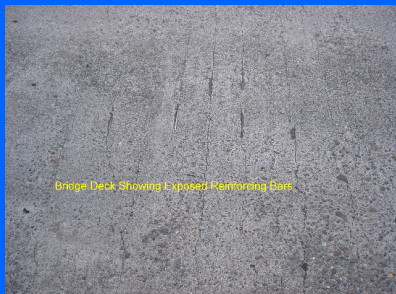
Bridge Deck Showing Exposed Reinforcing Bars

**Deck Condition**

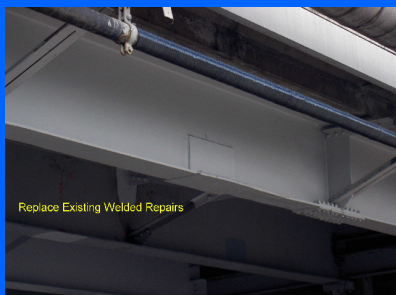
**Welded Repair in Bottom Flange**

Replace Existing Welded Repairs

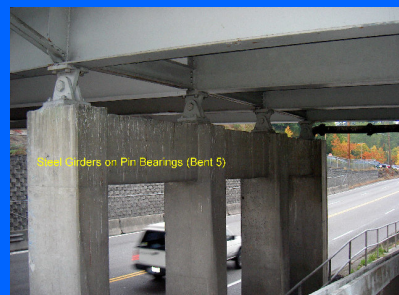
Base Girders on Pin Bearings (Bent 5)

**Seismically Vulnerable Tall Bearings**

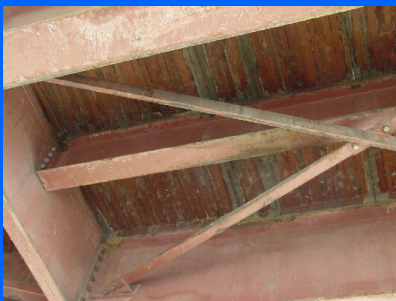
Paint Condition

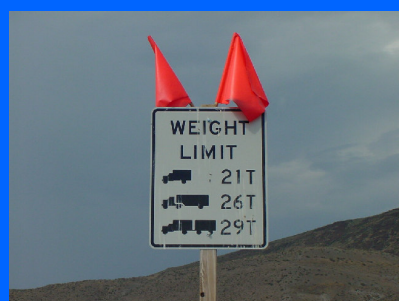
Load Posting

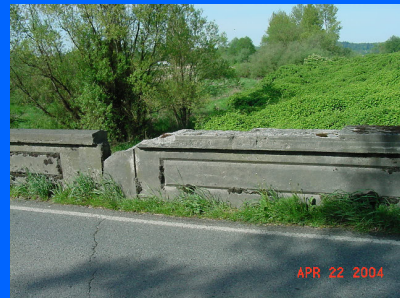
**Typical Barrier Damage**

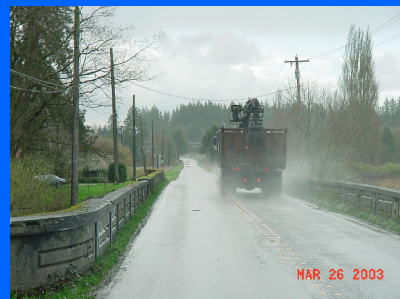
**Bridge is Narrow for Truck Traffic**
